Model No.
Sea Sparrow

STRUCTURAL AND ENVIRONMENTAL
TEST REPORT
FOR THE
NATO SEA SPARROW
FOLDING WING PROGRAM

Report No.
BR-6253

Static structural, dynamic structural and environmental tests were conducted on the NATO Folding Wing Assembly and Torsion Bar. The Folding Wing Assembly and Torsion Bar successfully withstood structural and environmental tests which were conducted under this program.

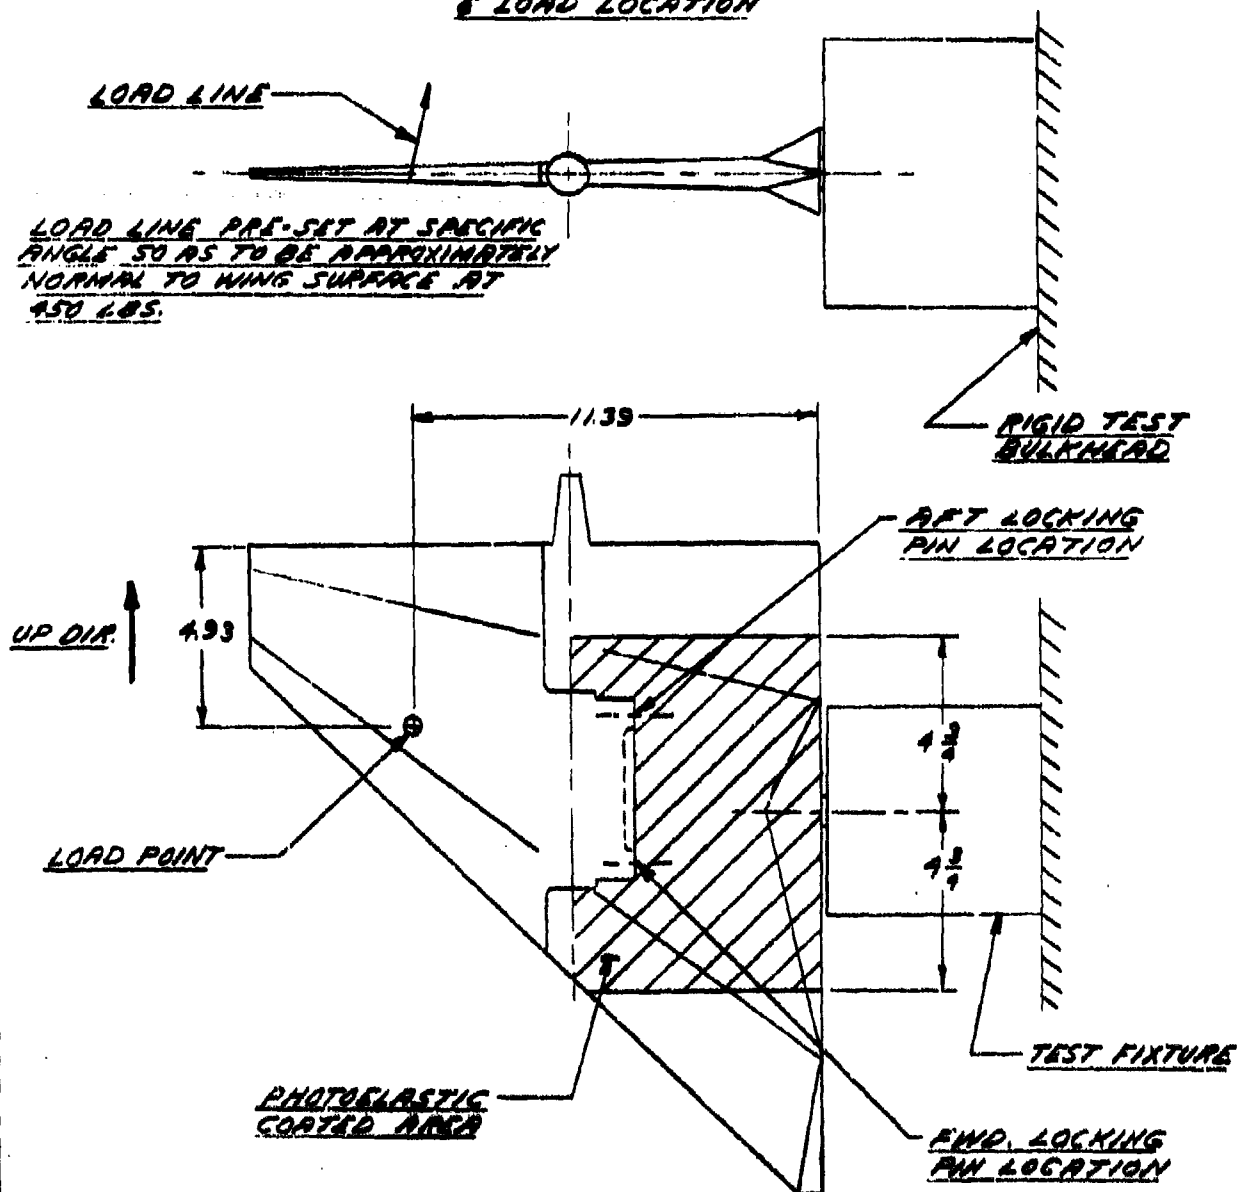
FIGURE 2

CRITICAL LOADING SURVEY
TEST ARRANGEMENT
& LOAD LOCATION

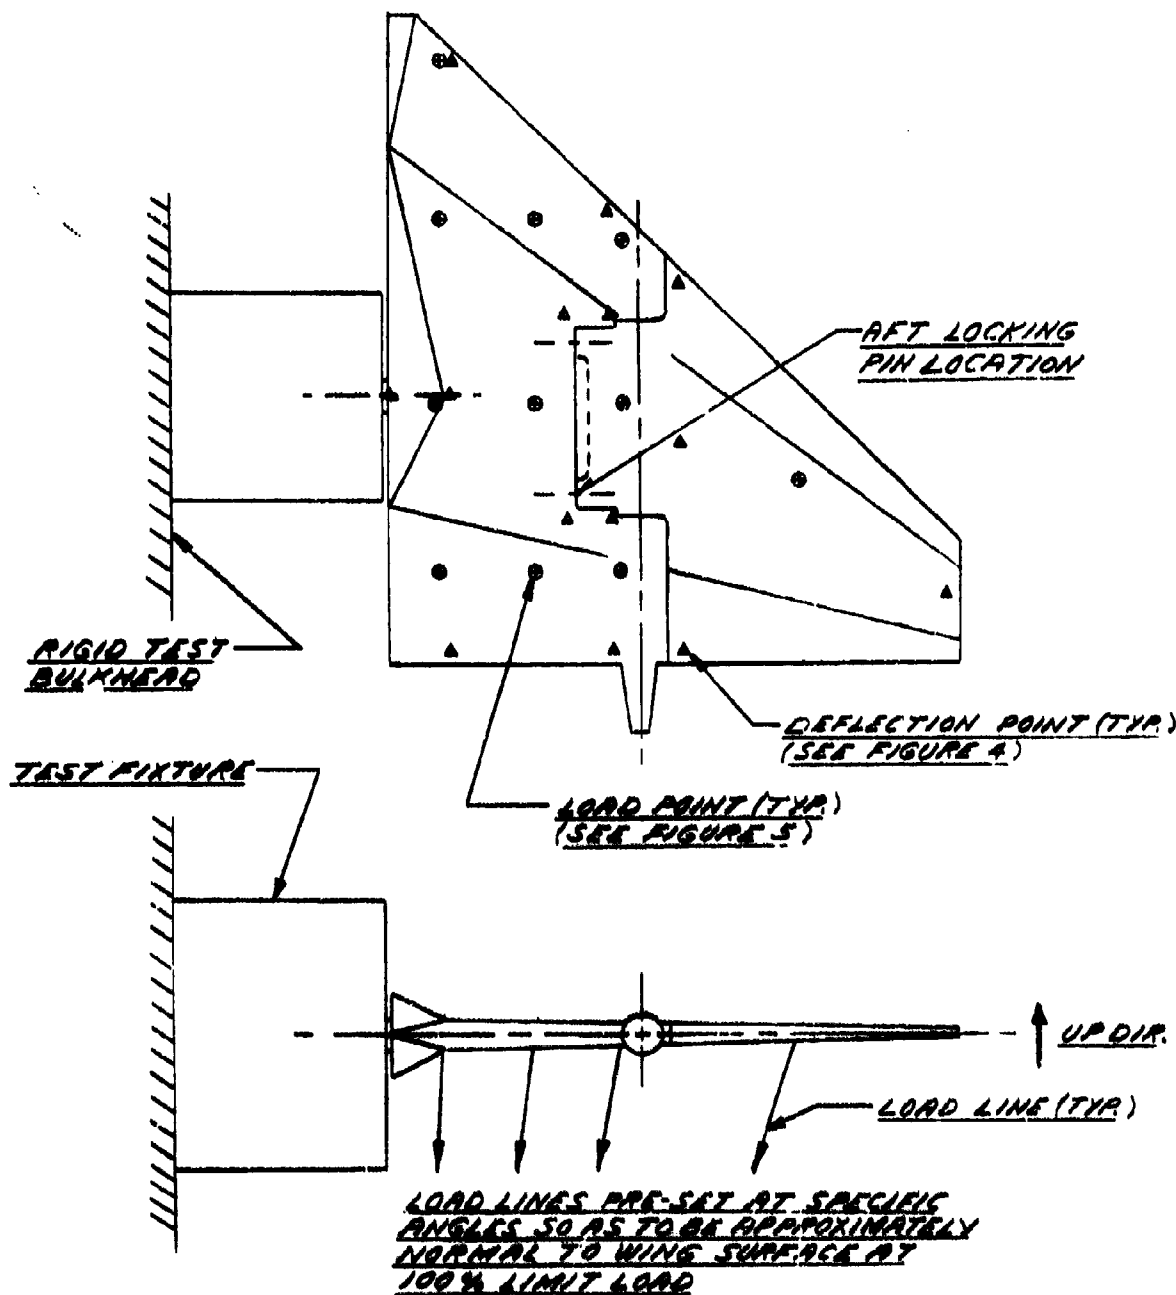
FIGURE 3

STATIC LOAD TEST NO. 1
TEST ARRANGEMENT

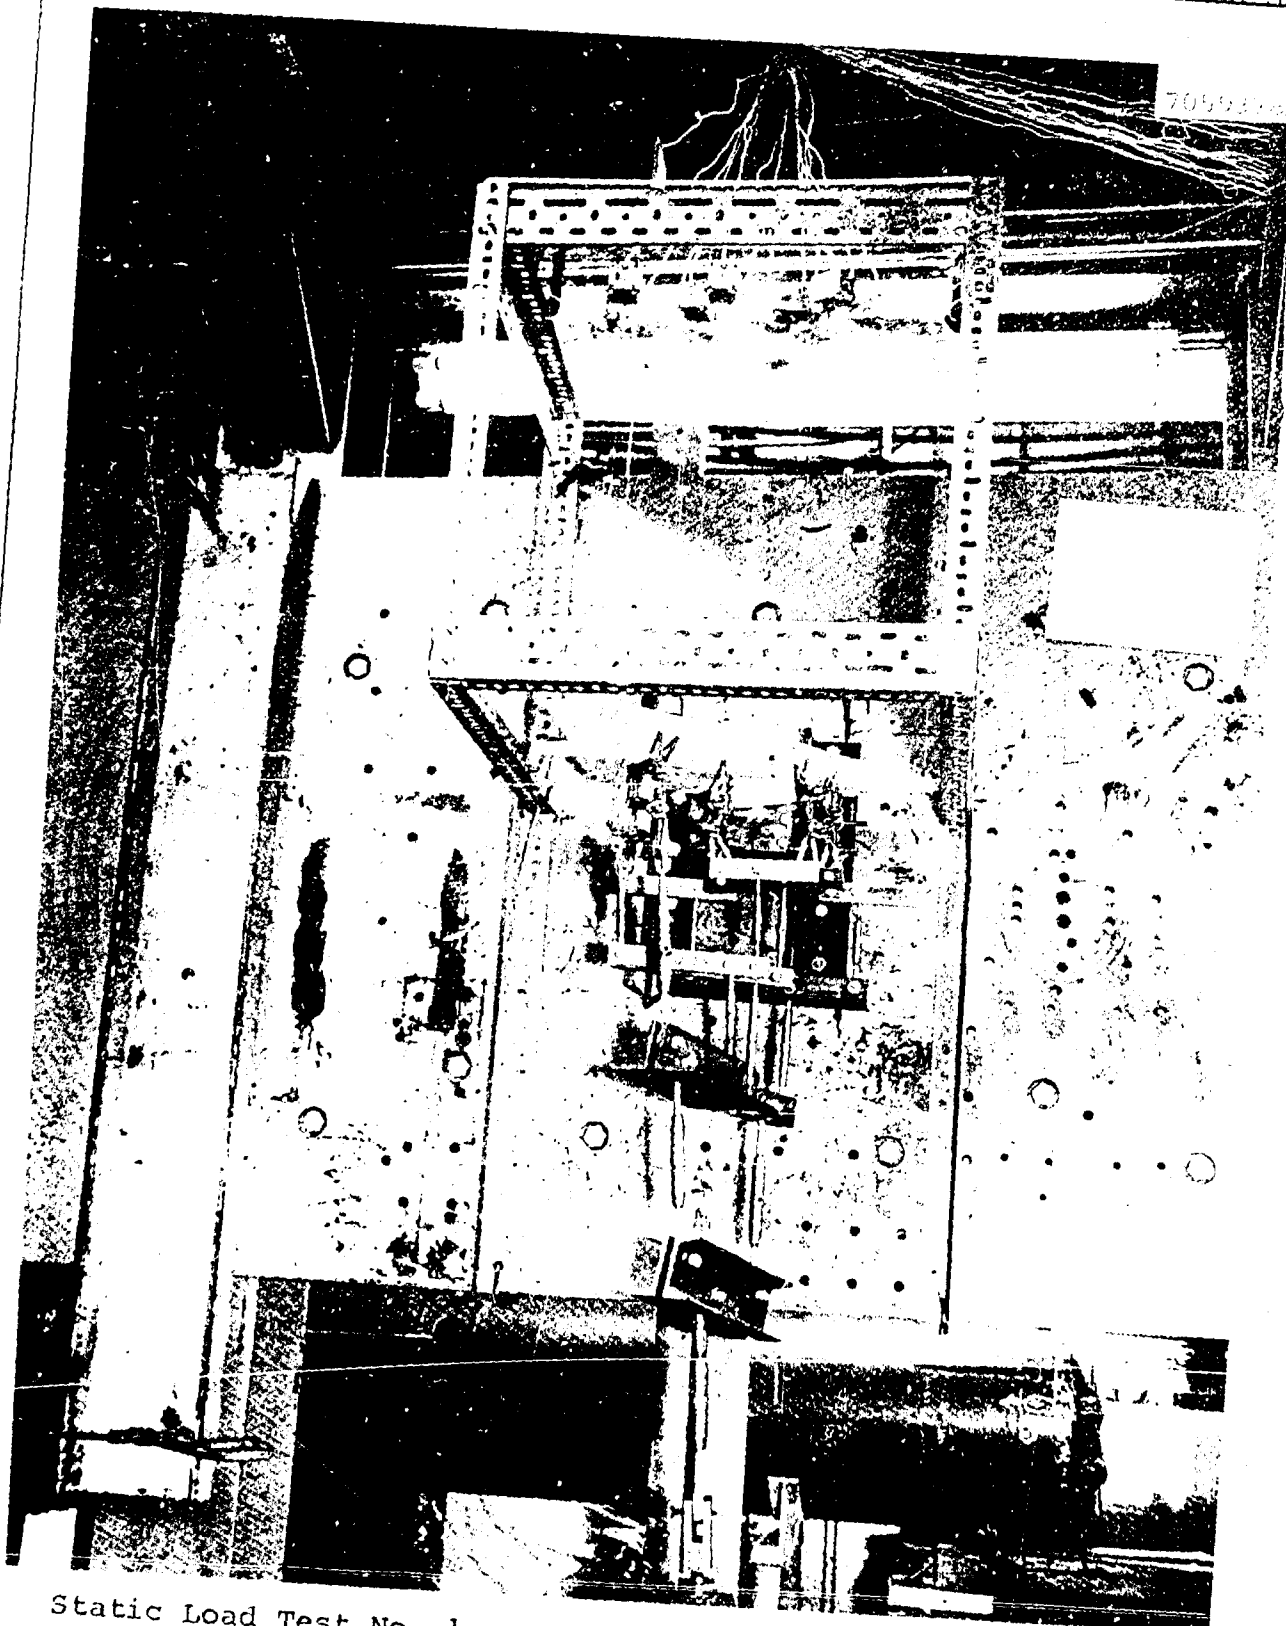
Static Load Test No. 1 - Test Setup - Overall View

To apply the loads to the folding wing, steel wire cables with swaged ball-end fittings on one end were used. Those wire cables were passed through holes which were drilled in the folding wing at the load points. A spherical ball end-mill was used to countersink one side of the holes. Those holes were small and had a negligible effect on the strength of the folding wing. The load on the outer panel of the folding wing was much greater than the other individual loads, and to prevent any local failure at that point, a 2-inch diameter steel pad with a rubber washer was used to distribute that load.

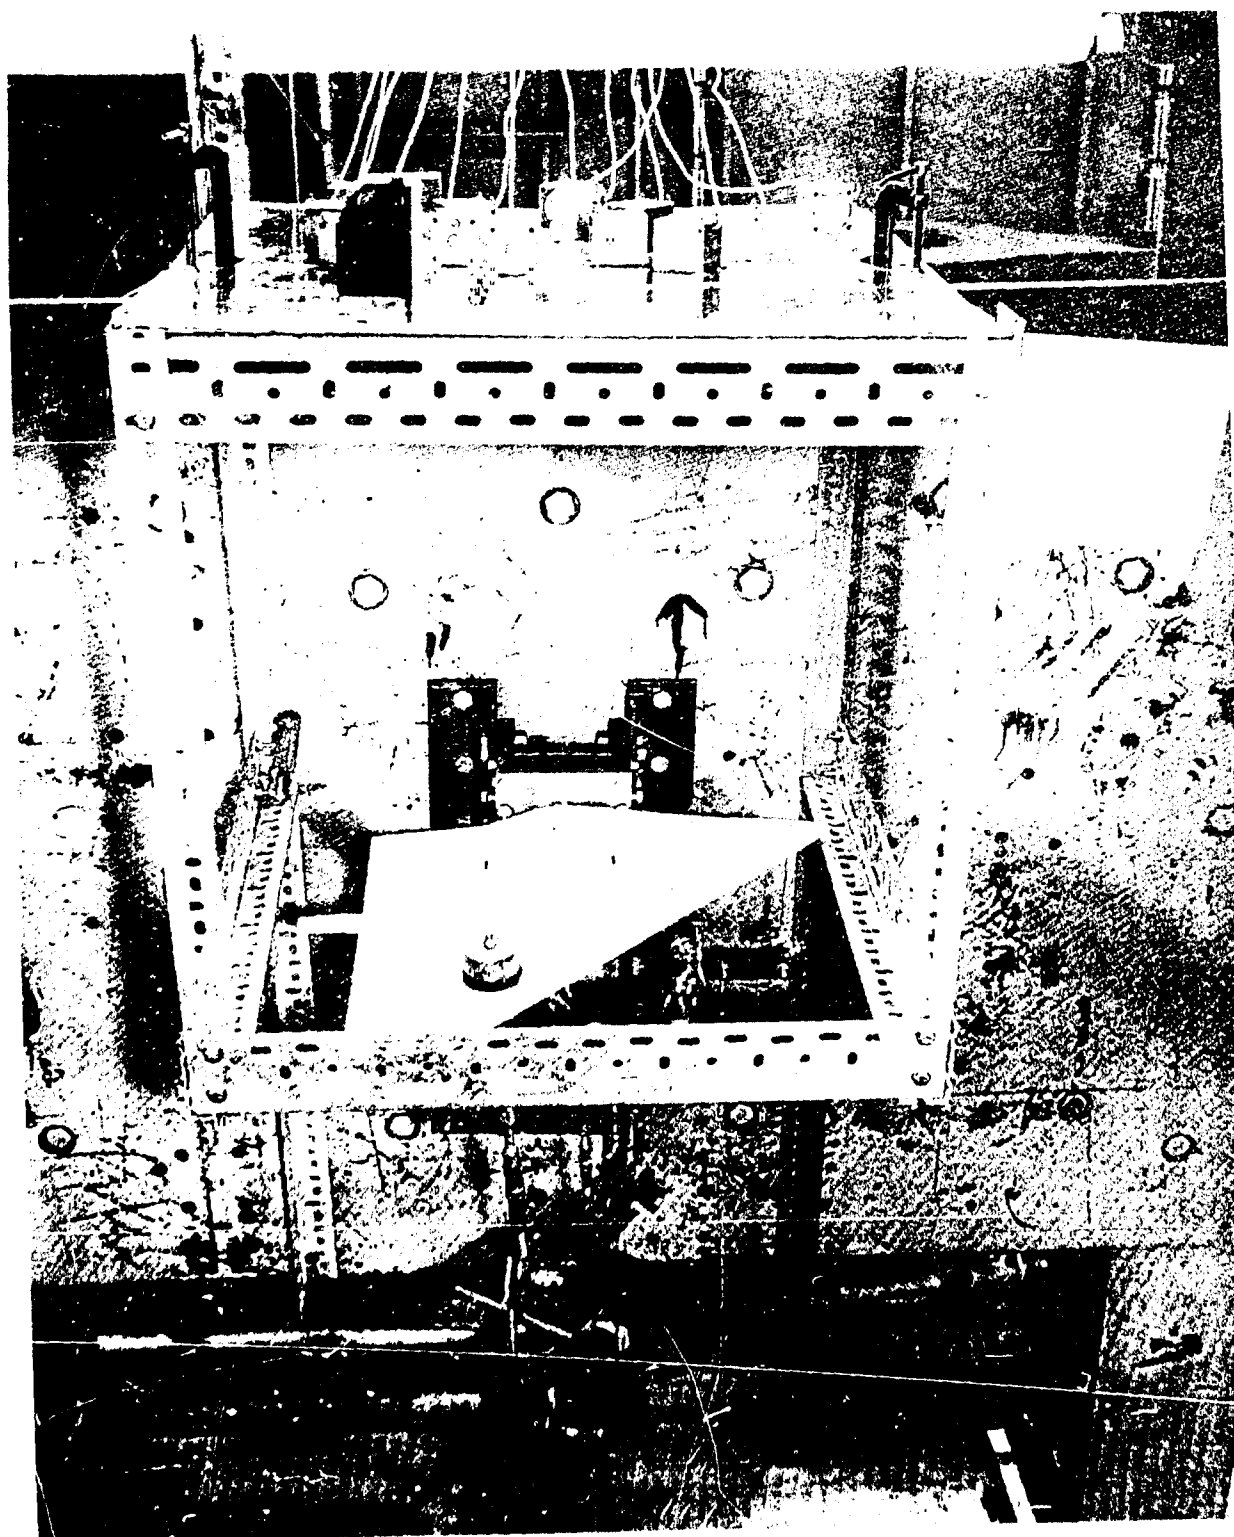
Static Load Test No. 1 - Test Setup - Top View

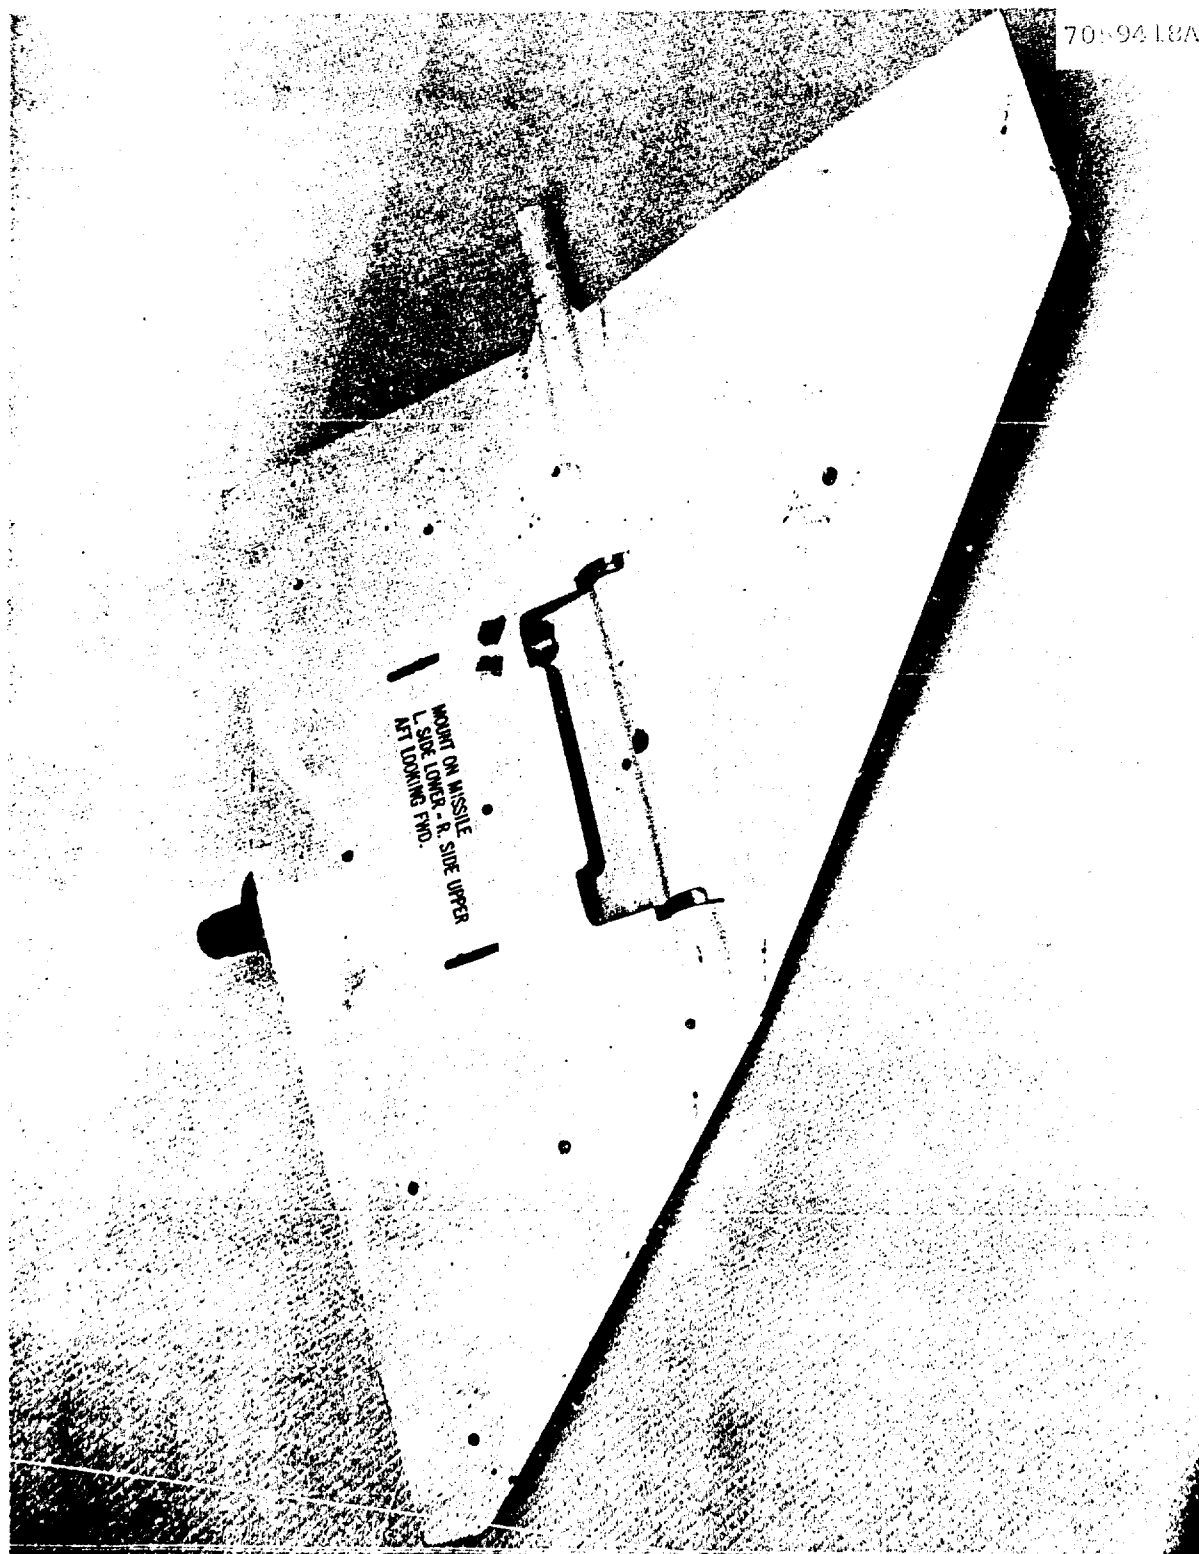
70-9418A

Static Load Test No. 1 - Failure of Outer Wing Panel

The folding wing, with only the aft locking pin engaged, failed at 129% of the temperature corrected design limit load, as the outer panel ruptured in the area of the aft locking pin engagement. The values at failure for the shear and bending moment at the root of the folding wing were 3020 lbs. and 22,640 in-lbs., respectively. Photographs of the failure are shown on pages 1.2.11 and 1.2.12.

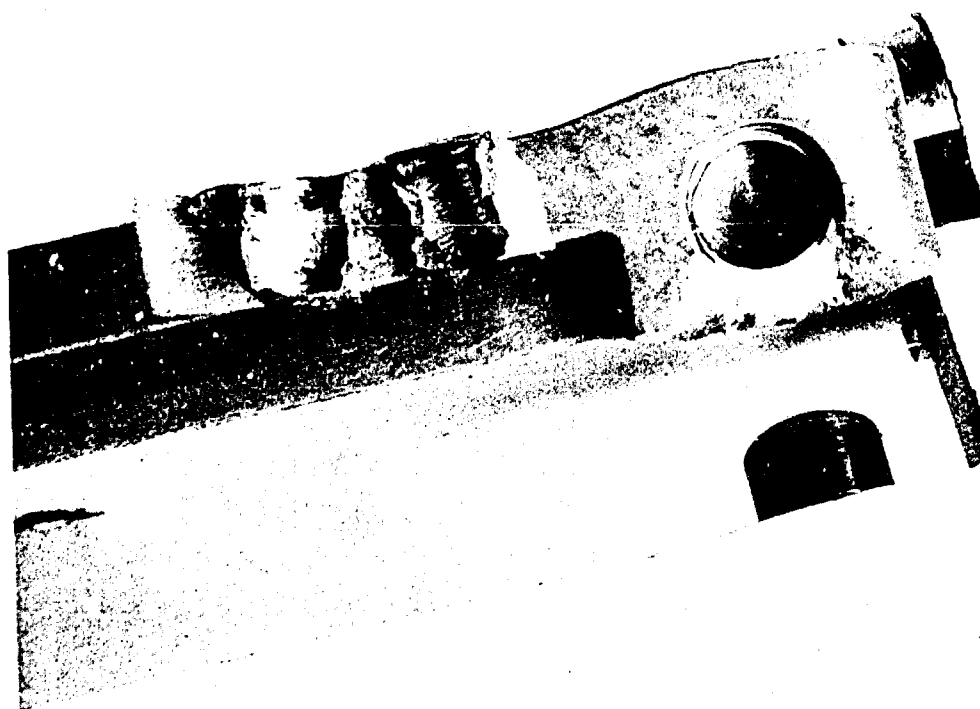
7059412A

Static Load Test No. 1 - Closeup of Failure of Outer Wing Section

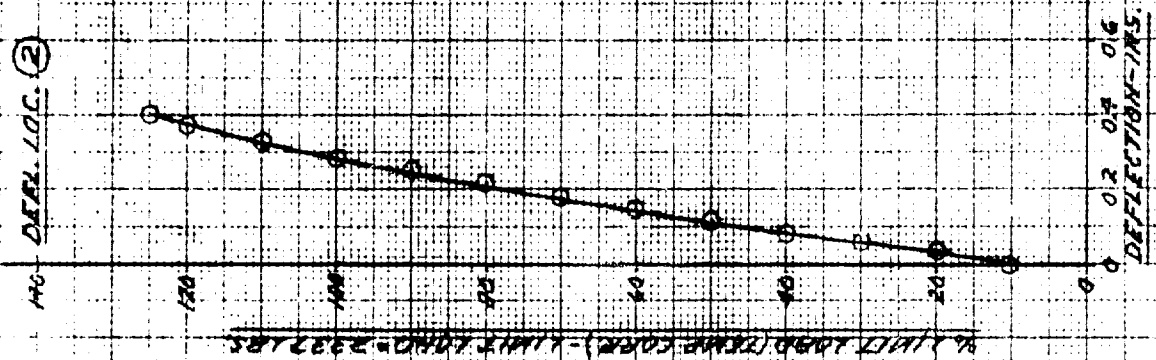
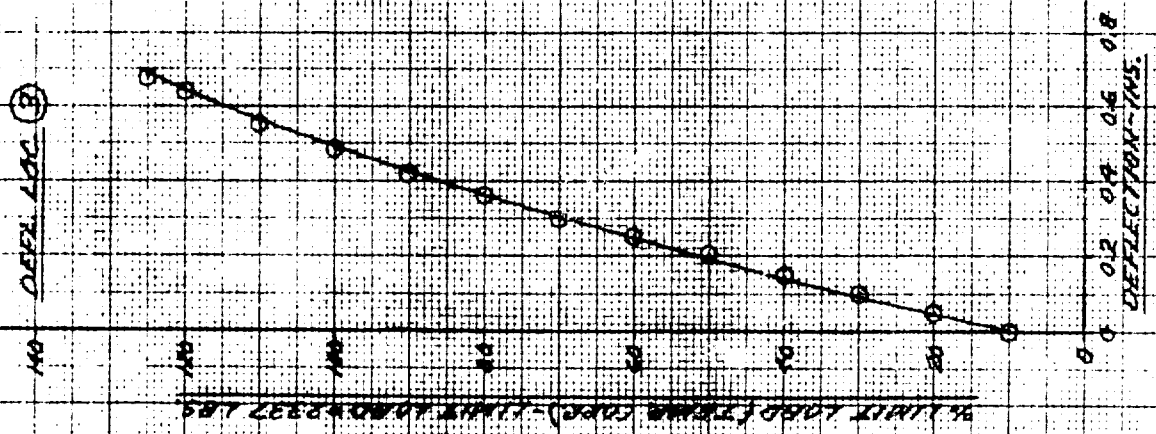
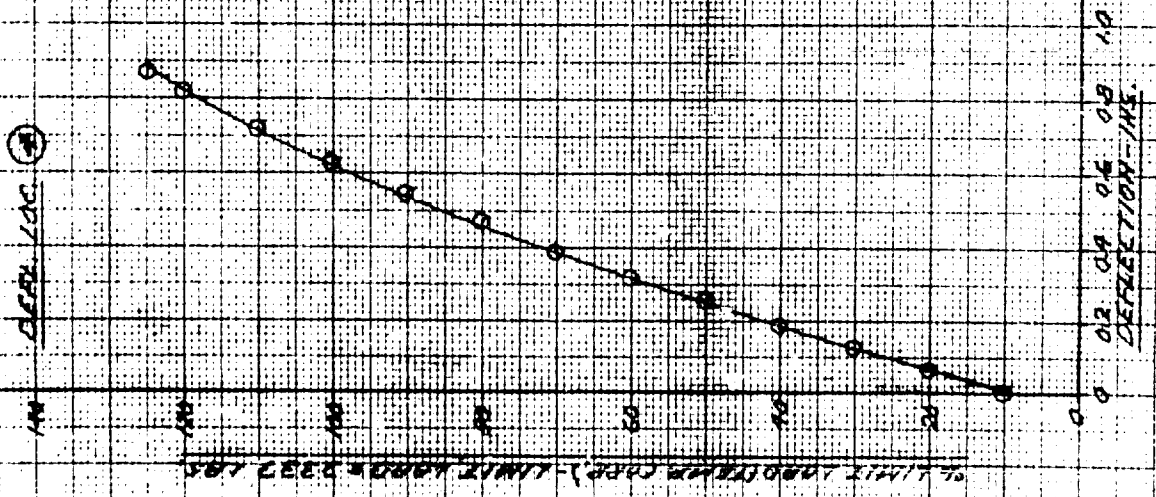
STATIC LOAD TEST NO. 1
CURVES - % LIMIT LOAD VS. DEFLECTION

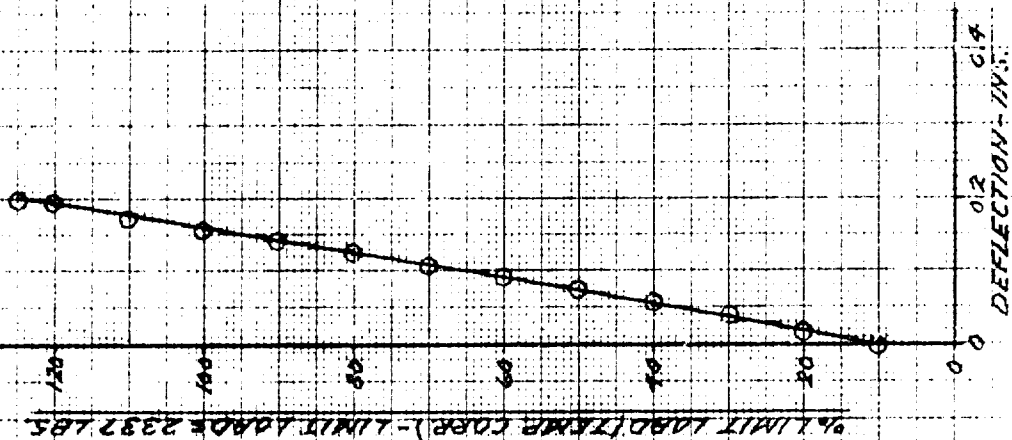
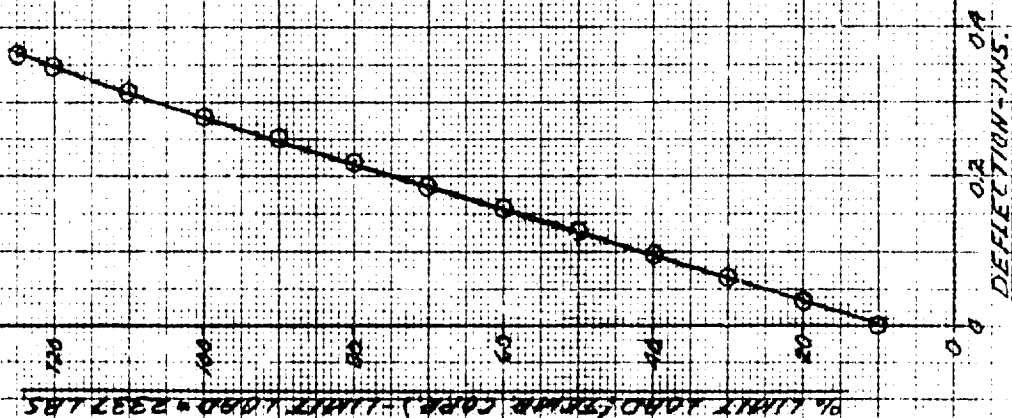
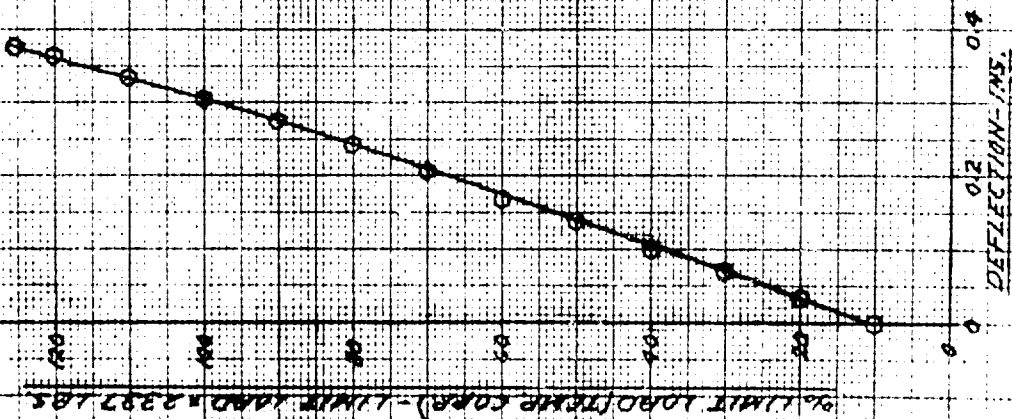
STATIC LOAD TEST NO. 1
CURVES - % LIMIT LOAD (TEMP CORP.) - LIMIT LOAD VS. DEFLECTION

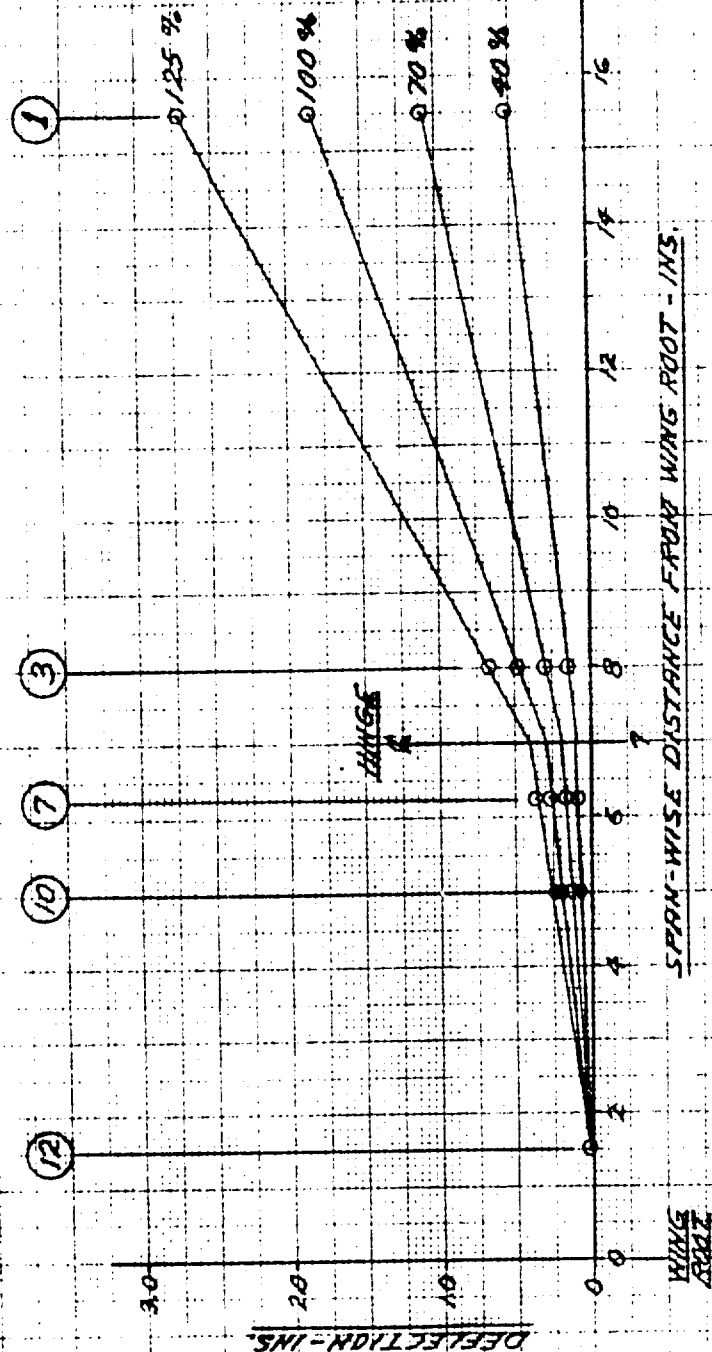
SPAN-WISE DEFLECTION CURVES

NUMBERS REPRESENT DEFLECTION LOCATIONS.

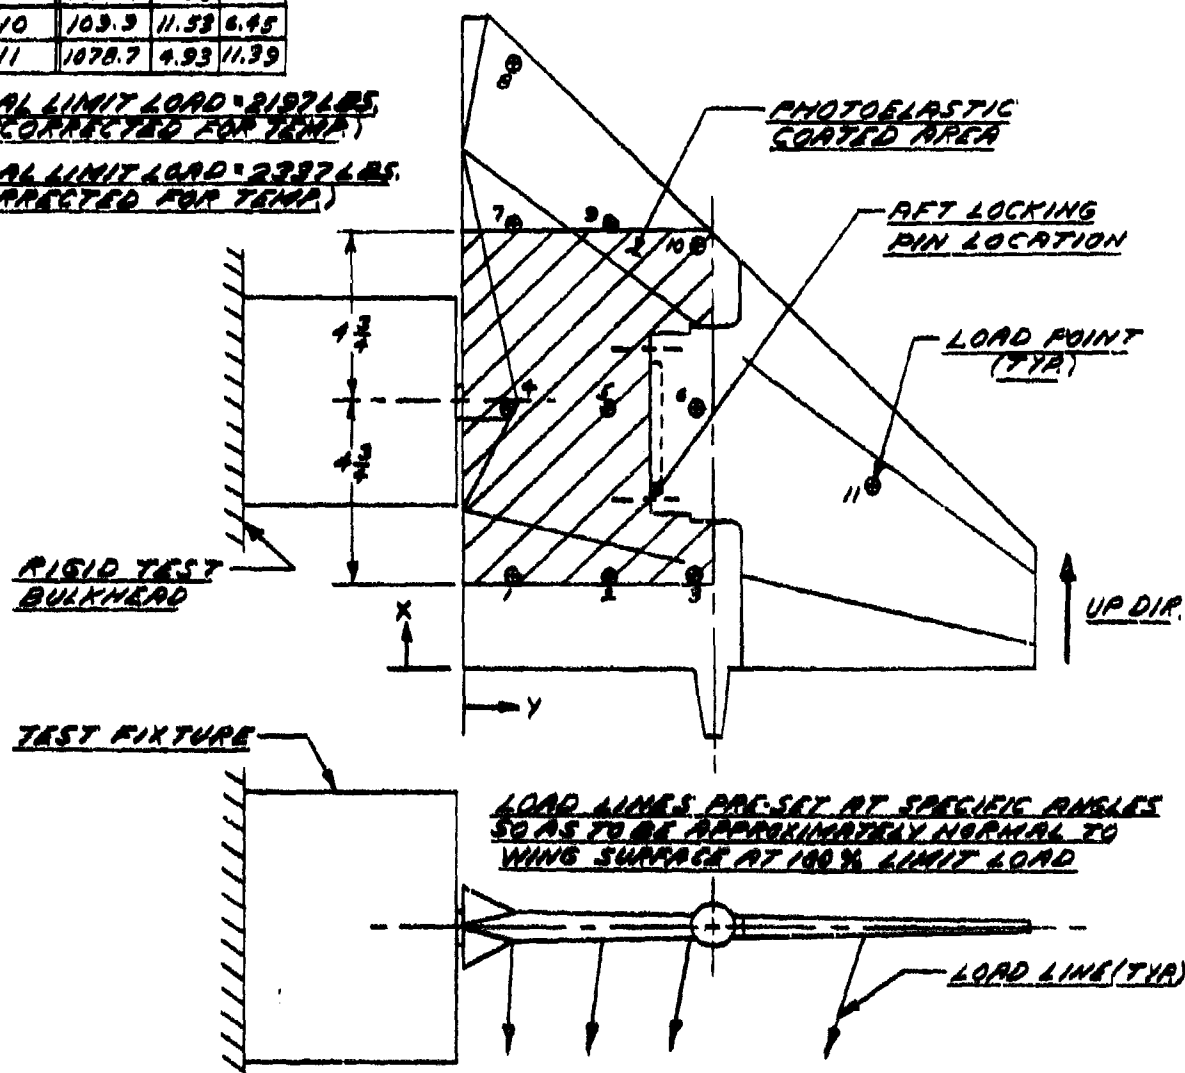
FIGURE 6

TOTAL LIMIT LOAD = 2337 LBS.
(CORRECTED FOR TEMP.)

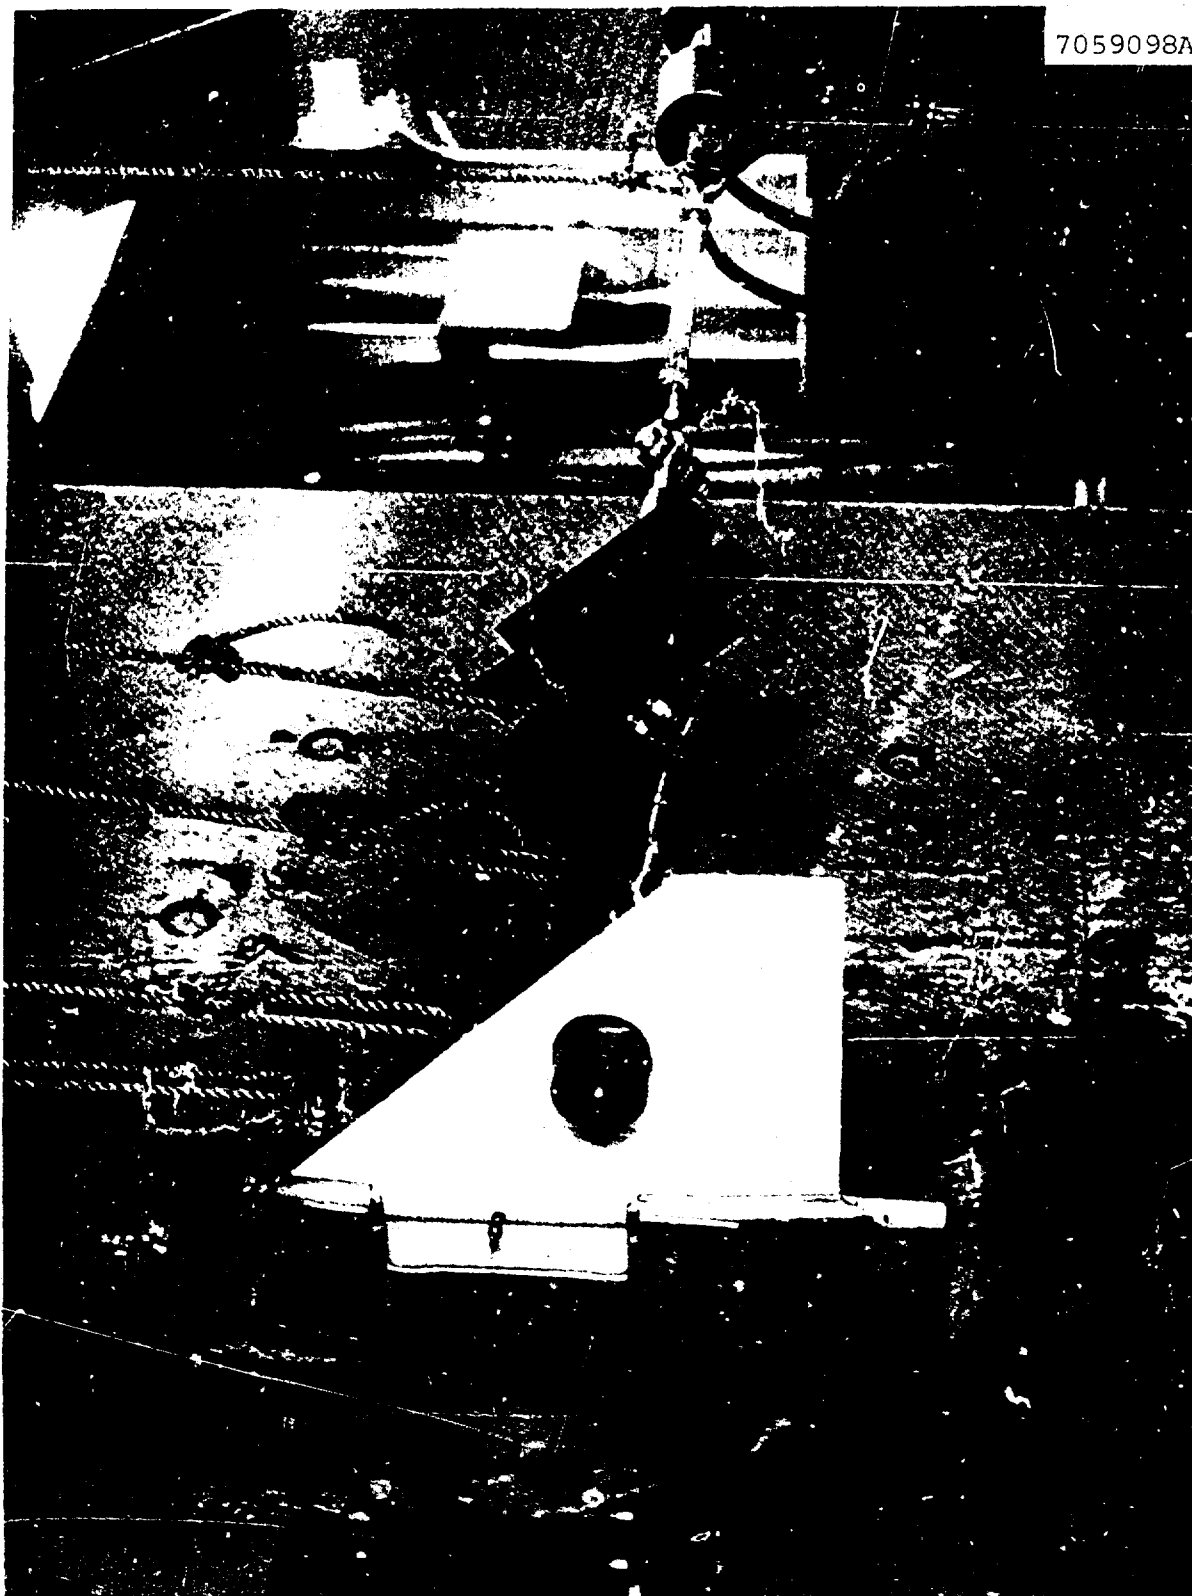
7059098A

Static Load Test No. 2 - Test Setup

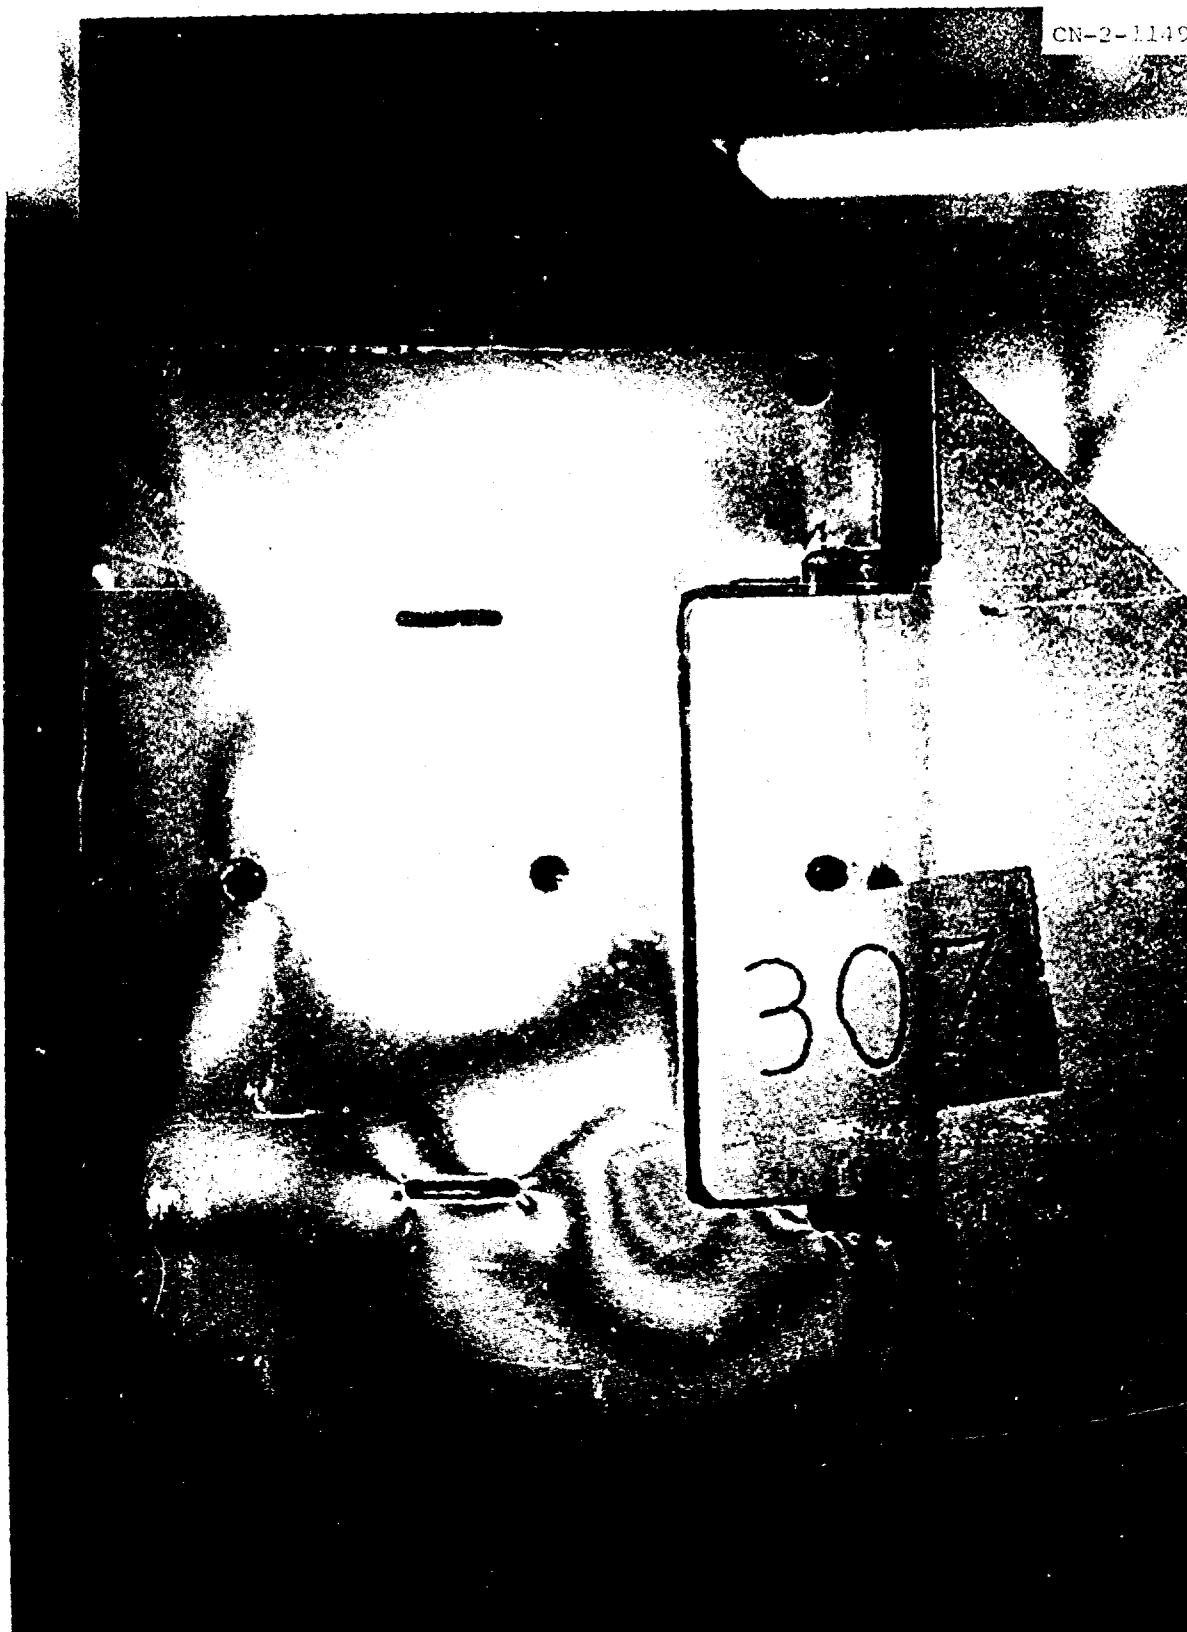
Static Load Test No. 2 - 30% Limit Load

Photographs of the developing stress pattern were taken at 30%, 50%, 70% and 100% of the temperature corrected design limit load. Those photographs are shown on pages 1.3.9, 1.3.10, 1.3.11 and 1.3.12, respectively. Unfortunately, the photoelastic material developed a crack at the highly stressed aft corner after 50% design limit load had been attained. However, the photographs do show the general overall picture of how the stresses developed throughout the inner panel.

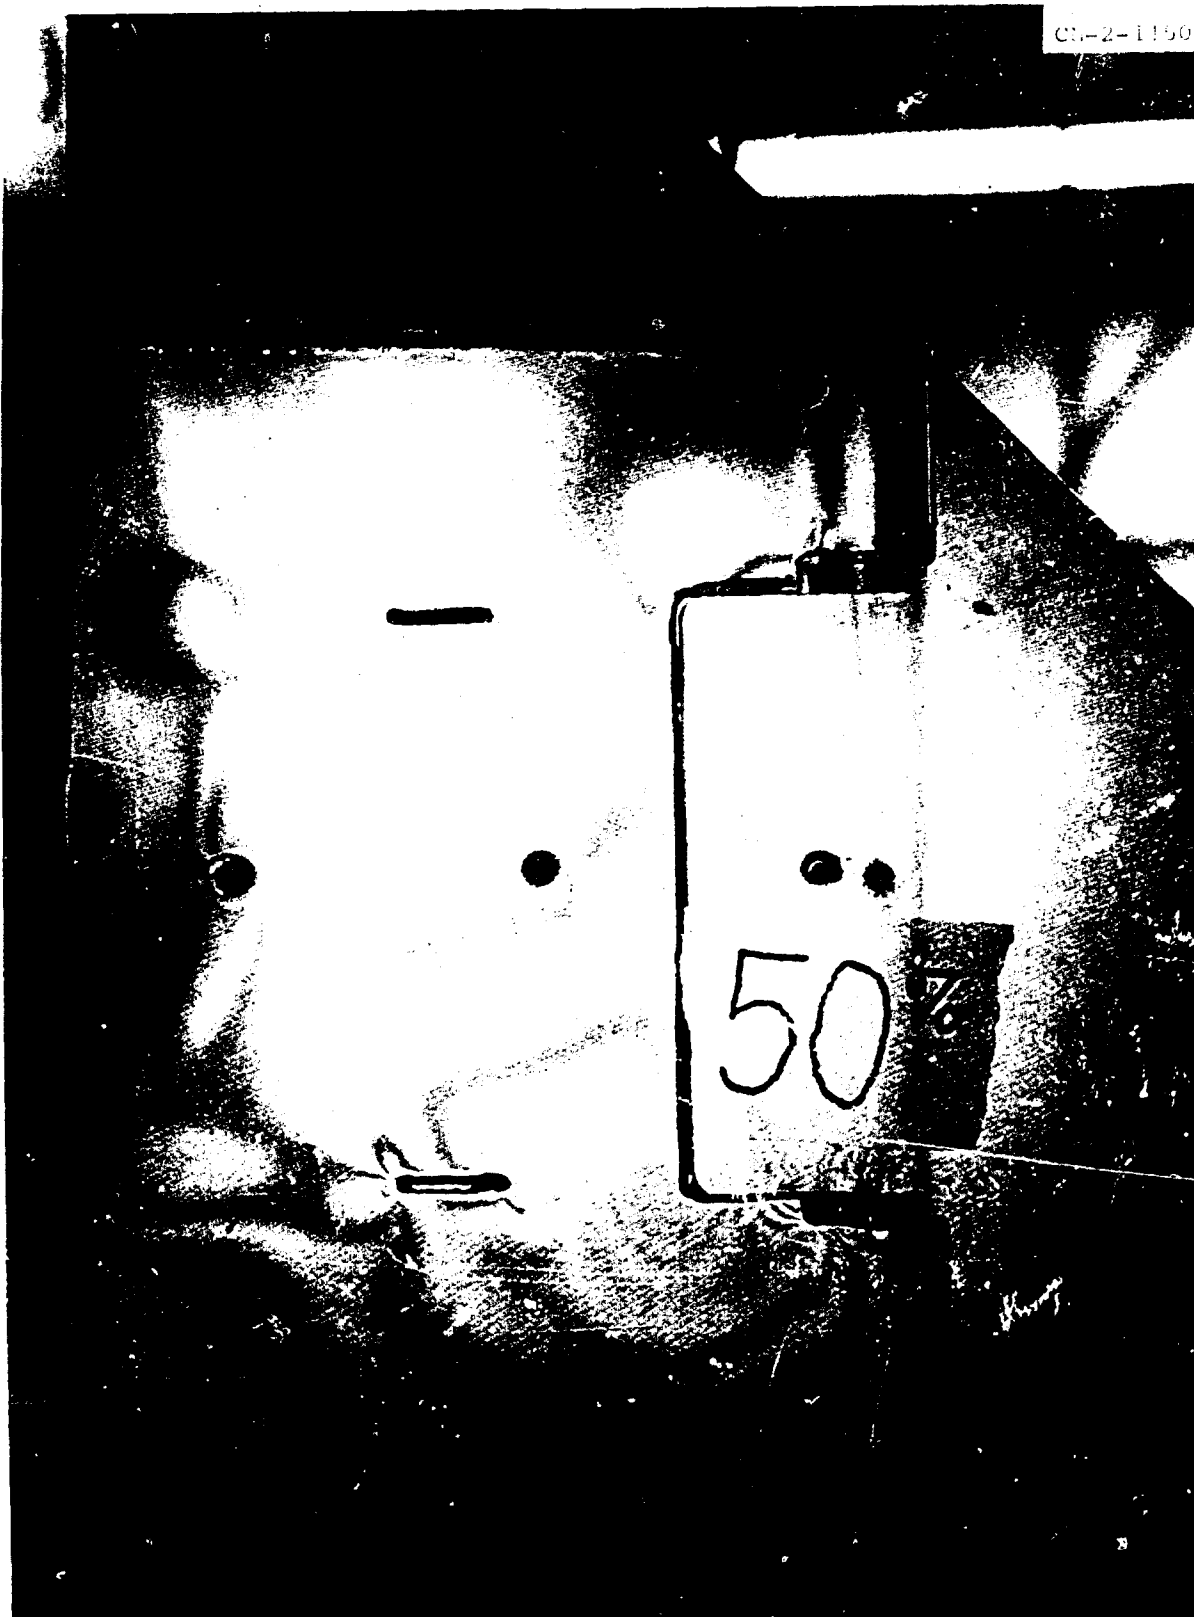
Static Load Test No. 2 - 50% Limit Load

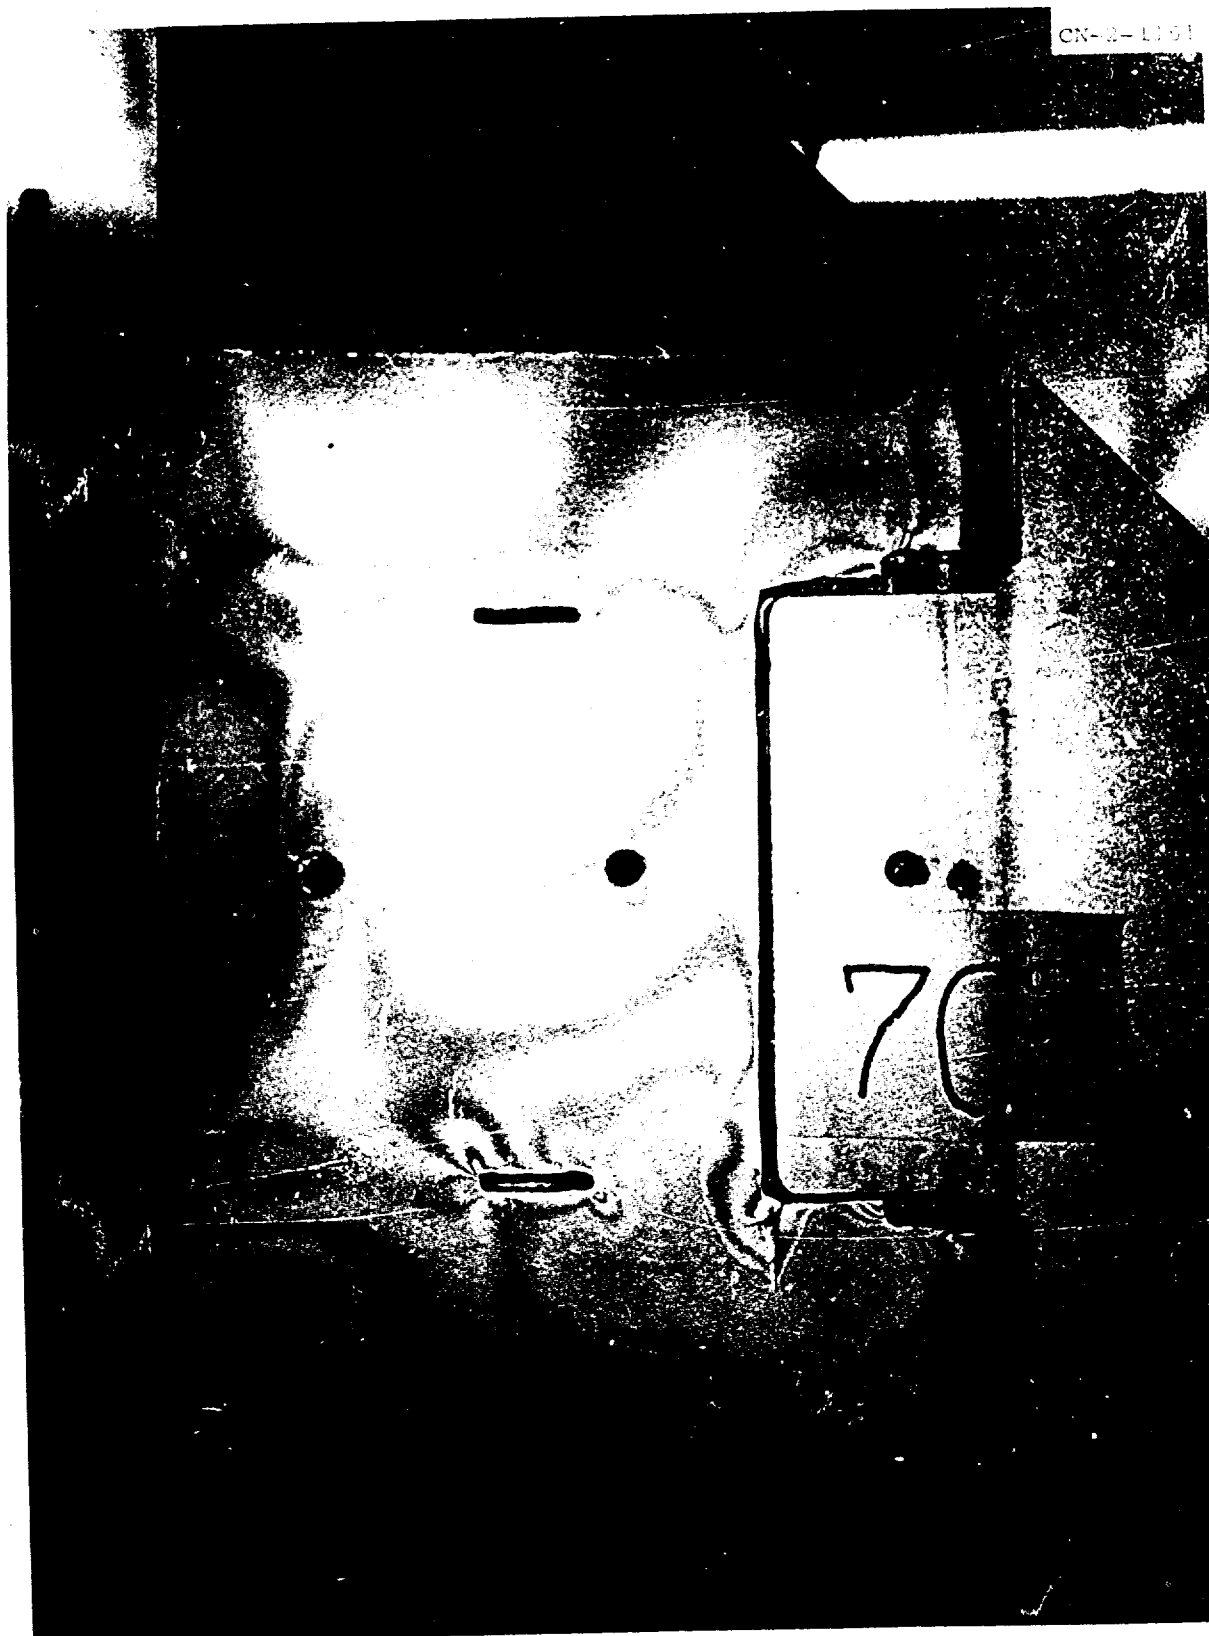
Static Load Test No. 2 - 70% Limit Load
